# **Navajo Abandoned Uranium Mine**

## **Site Screen Report**

### **A & B No. 3 AUM Site**

**January 2011**

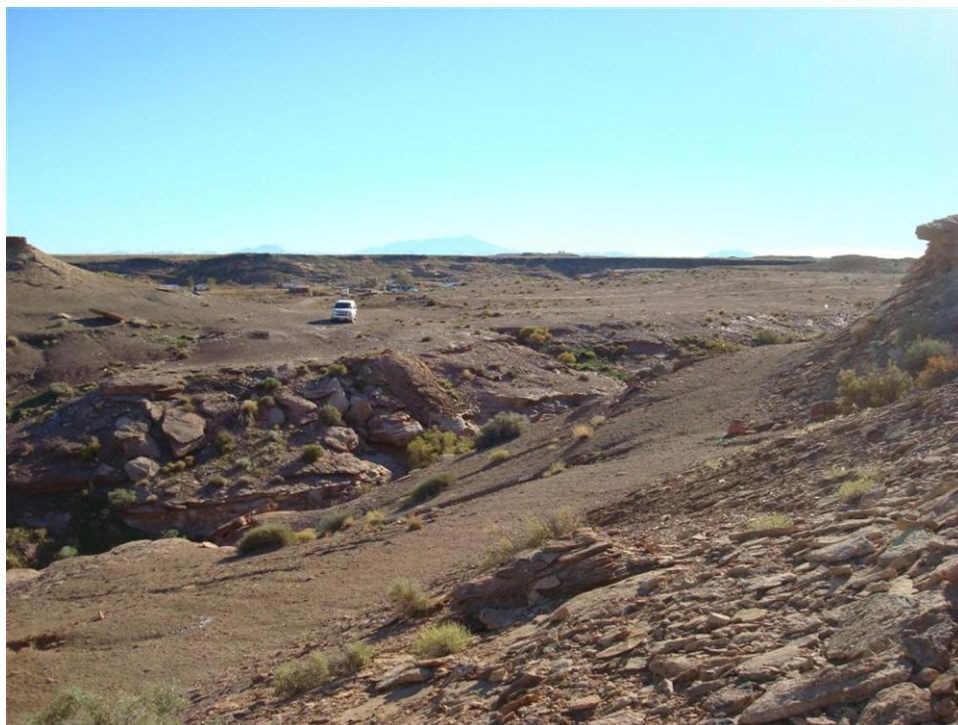
Photo 1. A & B No. 3 mine site

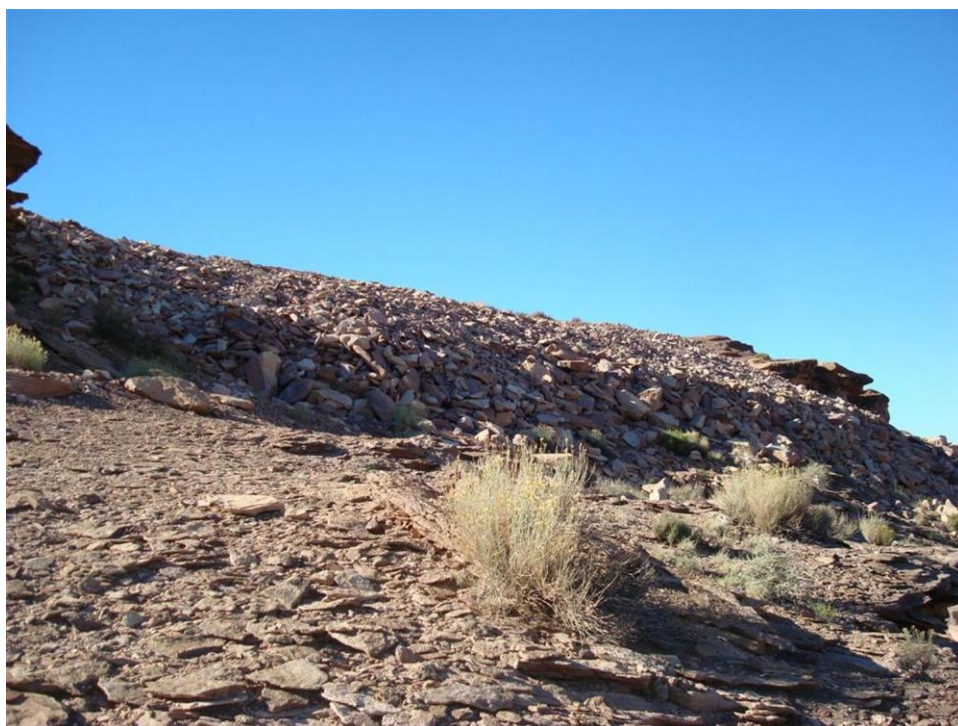
Many small waste piles throughout site, larger piles sloping towards Little Colorado River

Photo 2. A & B No. 3 mine site, waste rock

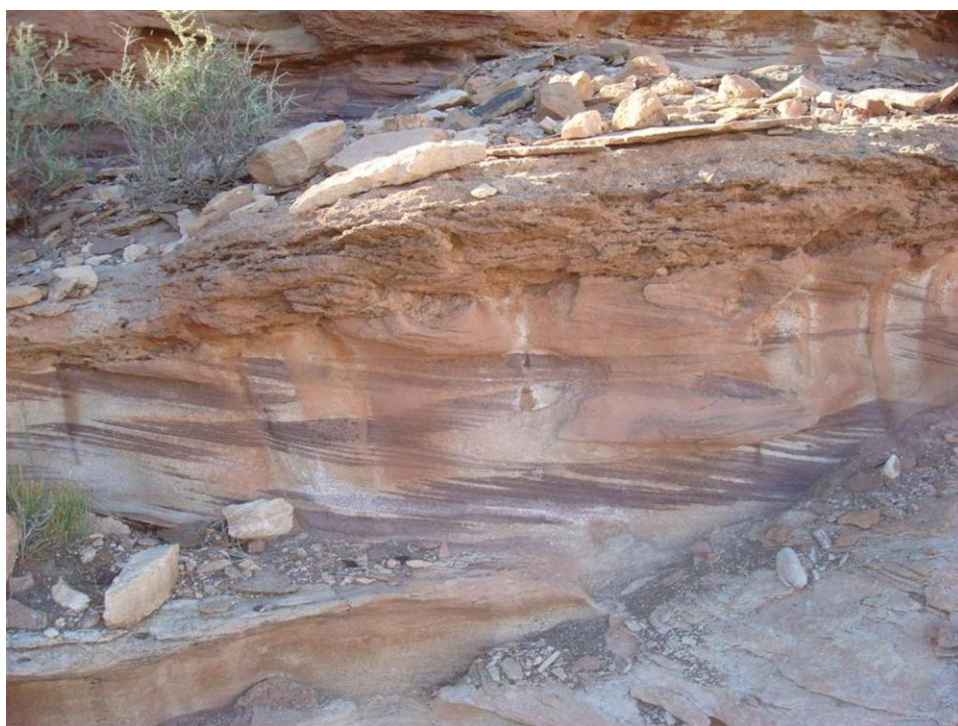
Photo 4. A & B No. 3 mine site, side wall

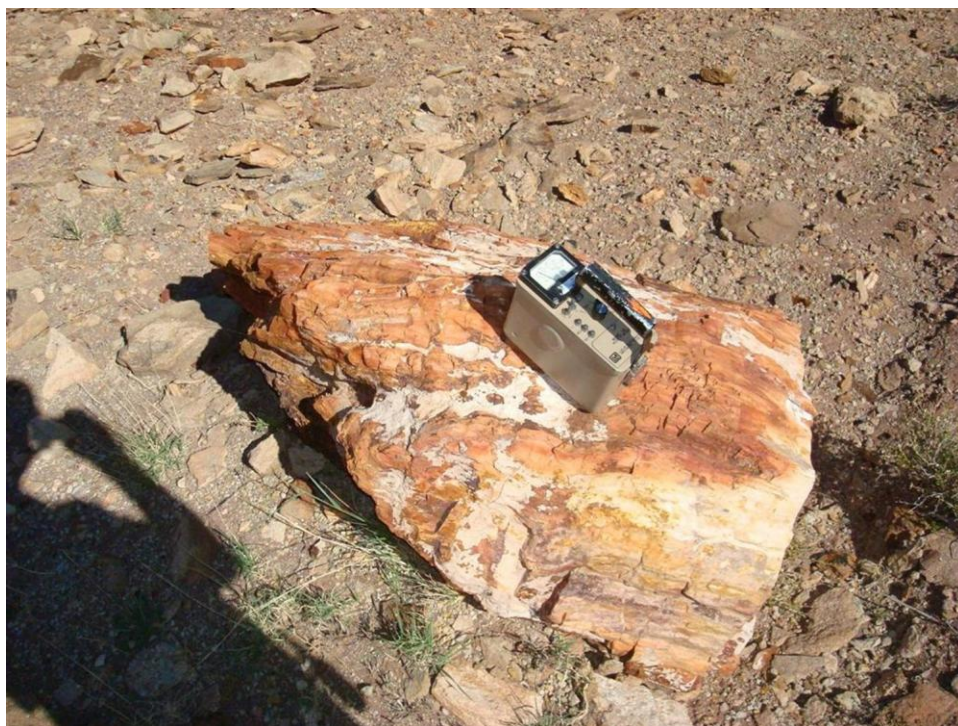
A total of 11,884 gamma radiation measurements were collected from the mine site, ranging from 4,730 cpm to 638,013 cpm. The measurements collected at the waste piles were found at maximum levels ranging from approximately 40,000 cpm to 640,000 cpm, and at background levels at the nearby homes and river basin. The measurements are represented in Figures 1 and 2.

Photo 5. A & B No. 3 mine site, elevated gamma readings

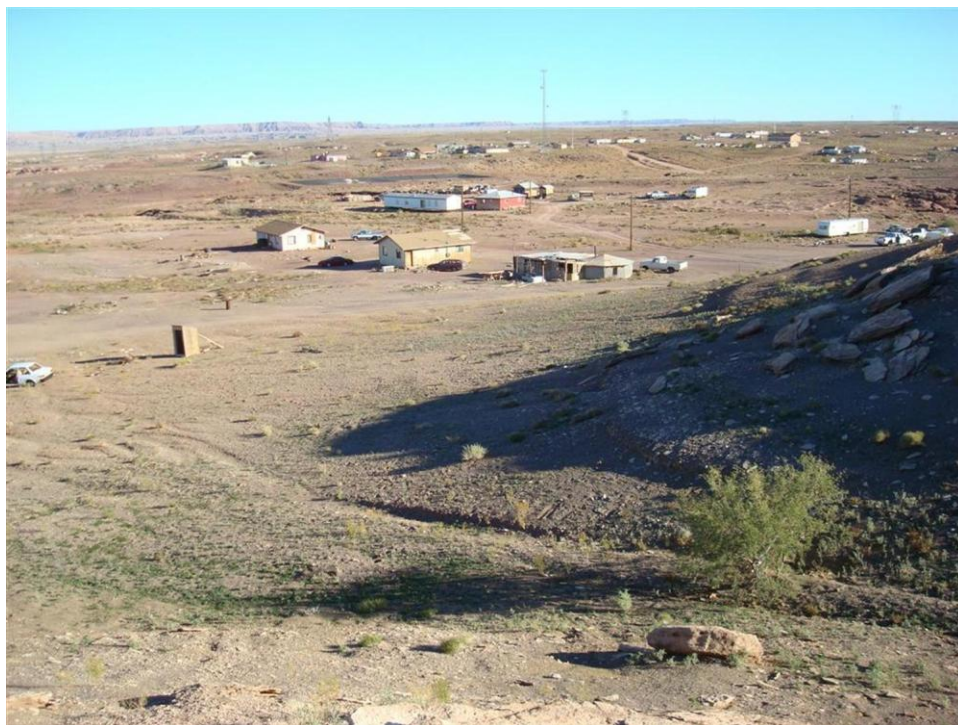
**200 feet to 0.25 mile:** 6 Residential Homes within 0.25 mi S of site

Background levels near all homes

Photo 6. A & B No. 3 mine site, nearby homes and structures

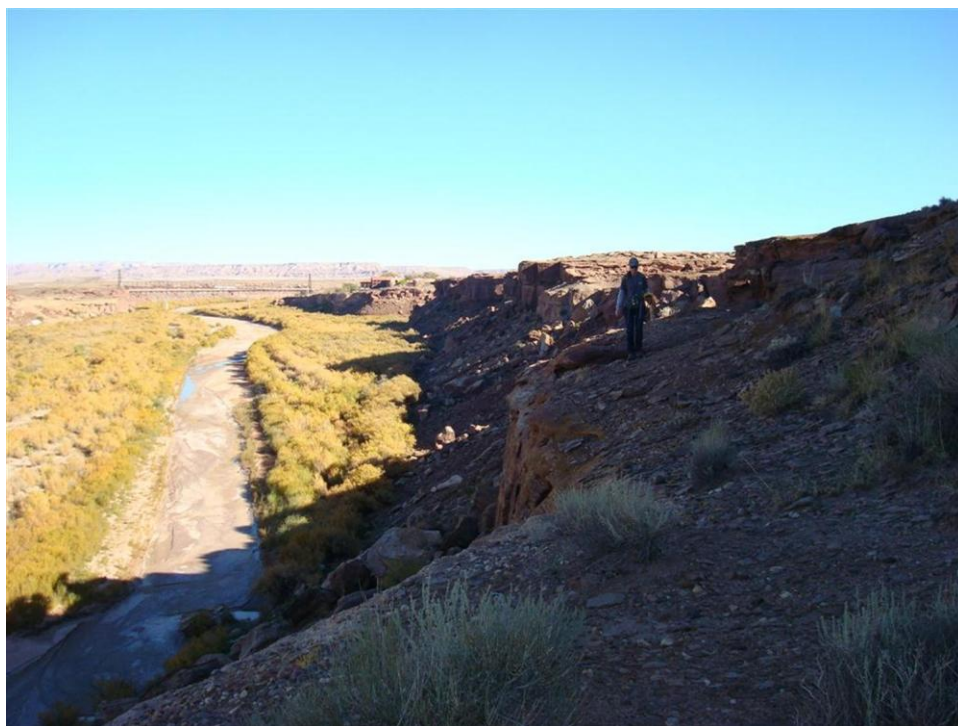
Little Colorado River Basin adjacent to the N of the site, possible wetlands

Photo 7. A & B No. 3 mine site, alongside Little Colorado River Basin
